# GLENHAM DAM

DUTCHESS COUNTY, NEW YORK  
INVENTORY NO. N.Y. 72

## PHASE I INSPECTION REPORT NATIONAL DAM SAFETY PROGRAM

AUGUST 1981

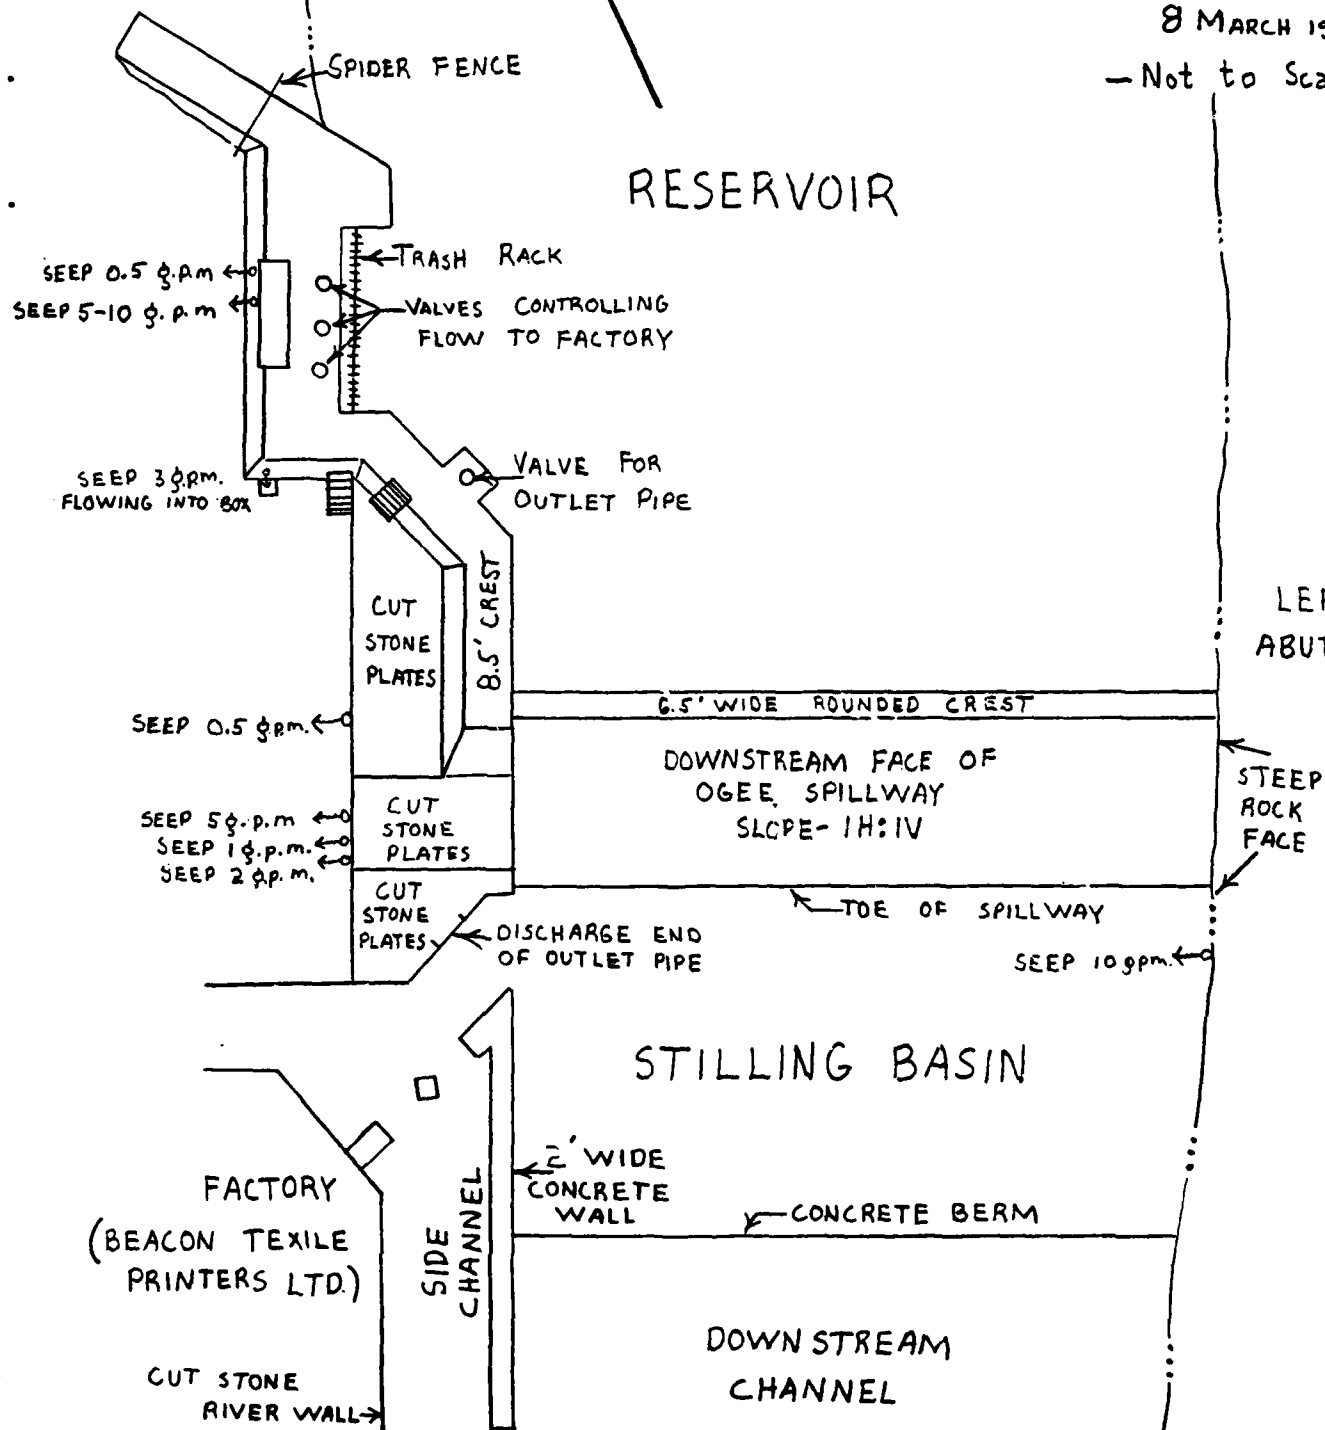
- NOTES: 1) SURFACES CAPPED WITH CUT STONE PLATES HAVE WEEDS AND BRUSH GROWING IN NEARLY EVERY JOINT.  
2) VIRTUALLY EVERY CONCRETE SURFACE SHOWS SIGNS OF SPALLING
